Dash Vent Repair http://forums.vwvortex.com/zerothread?id=2558035 A2B4Guy@VWVortex 4/15/07

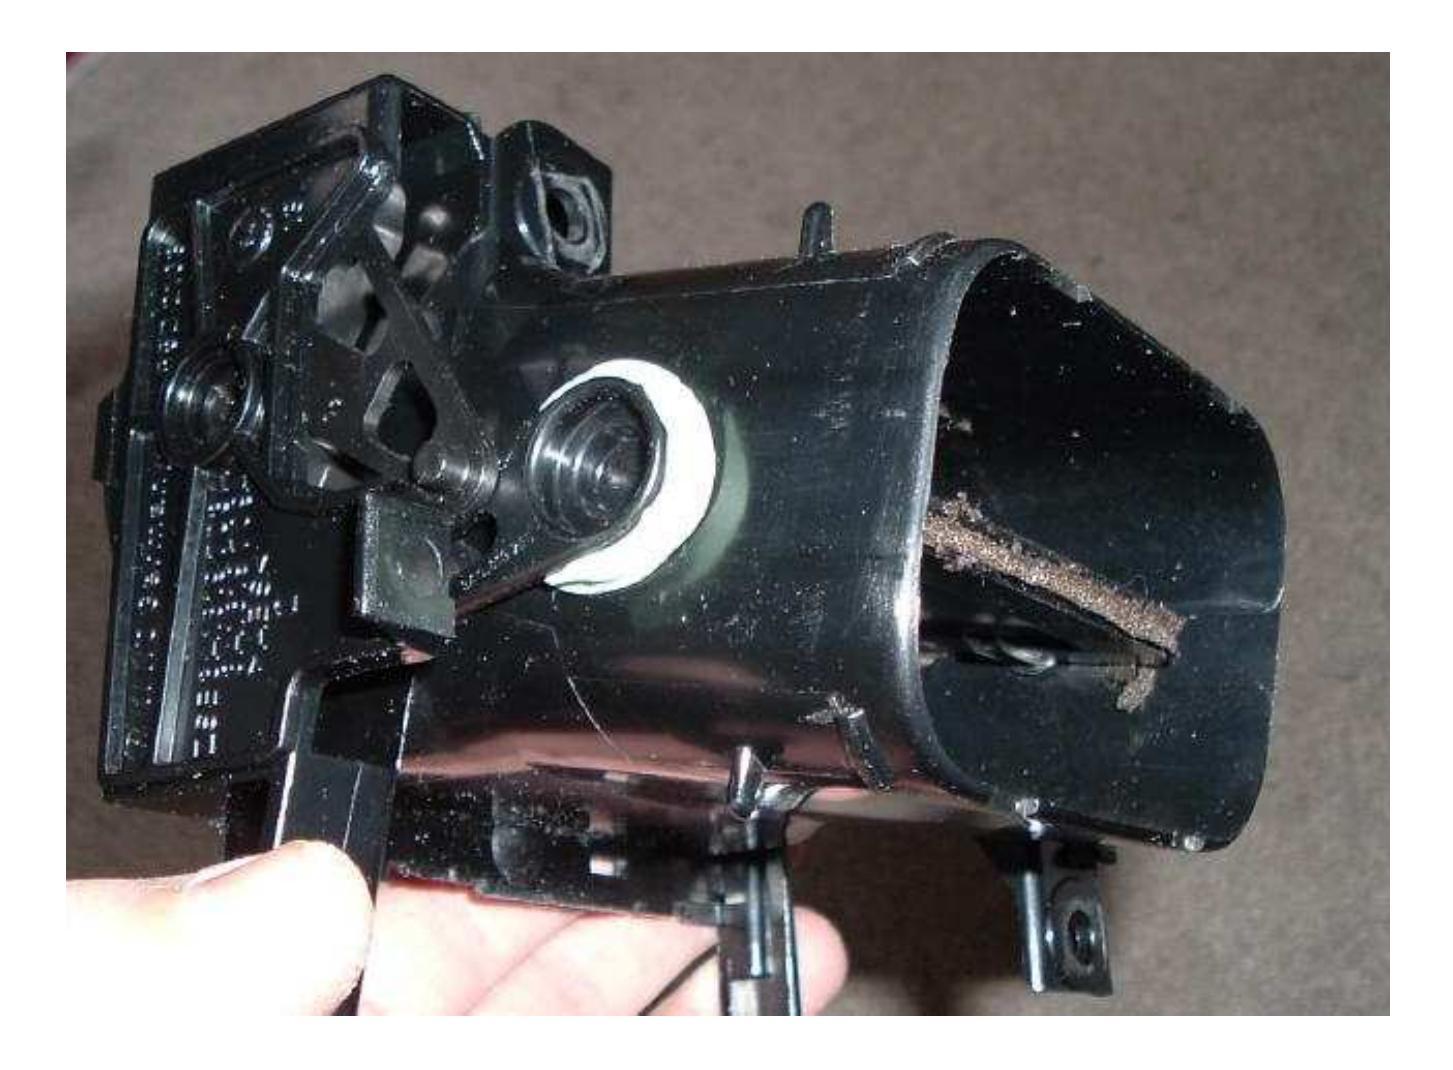
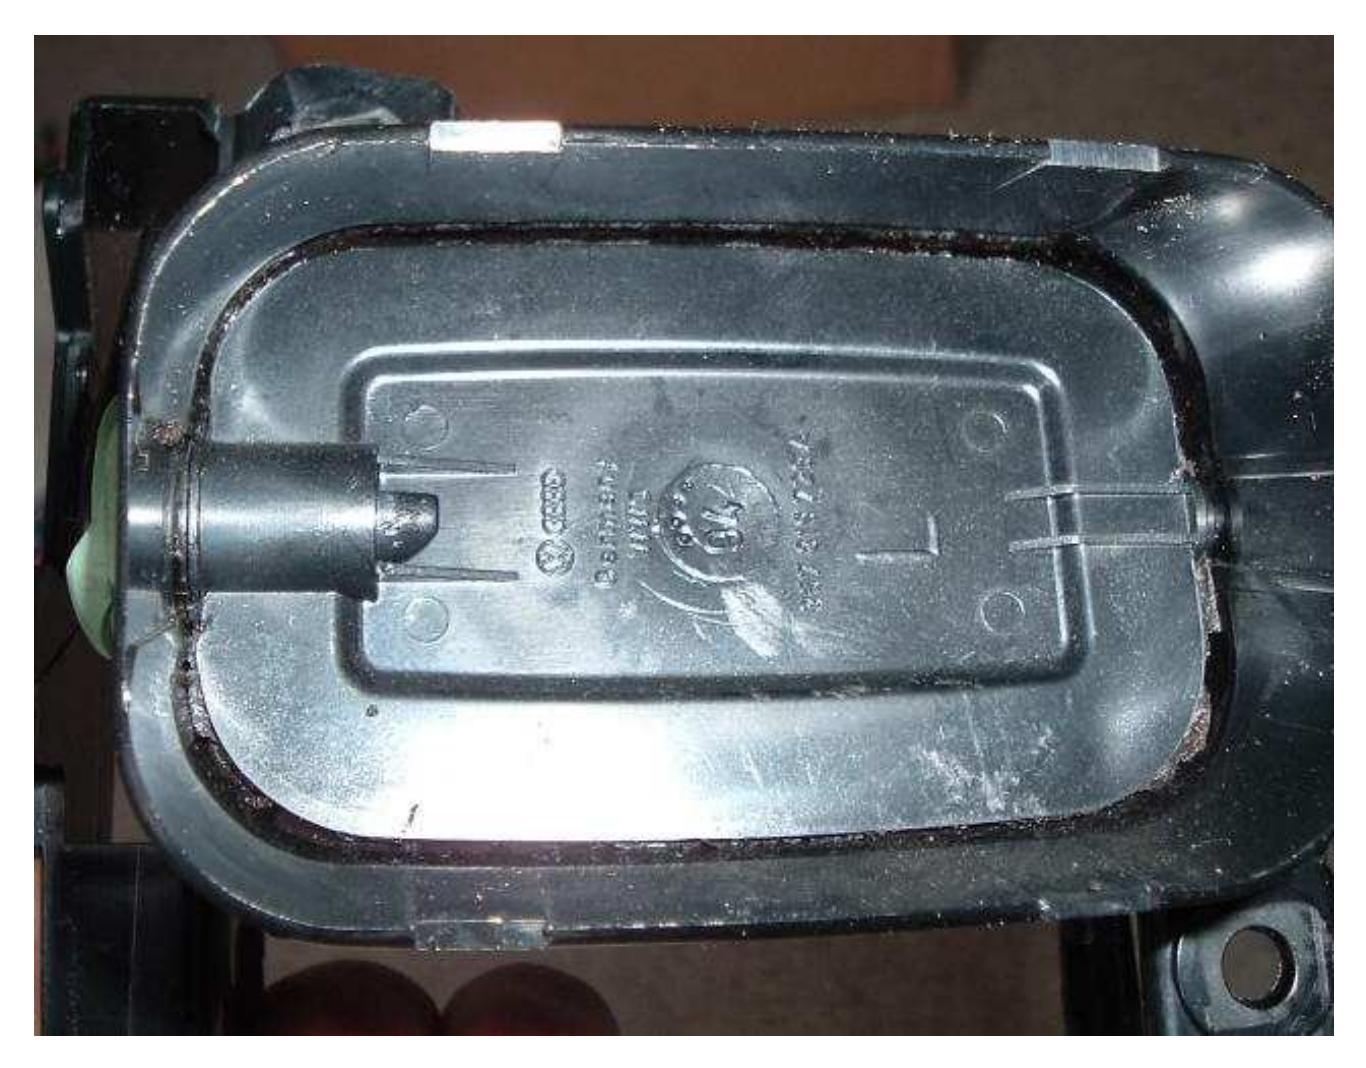
Here you can see the rotted foam around the edge of the flap. Also visible is a previous attempt at fixing the flap from blowing closed, a rubber band behind the link arm. This made the flap almost impossible to operate.

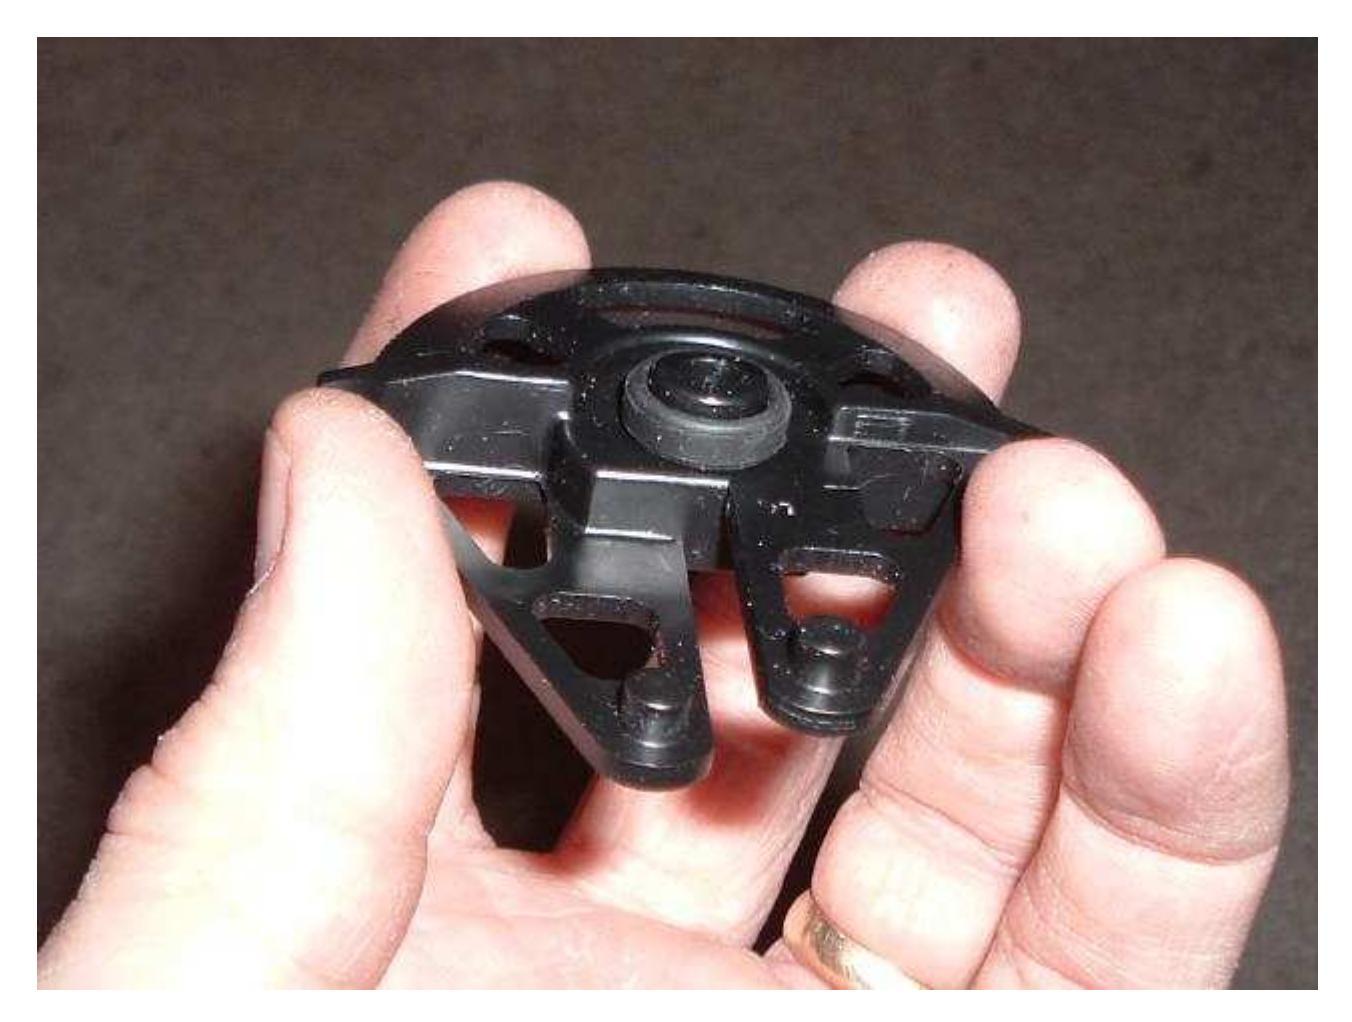
You must very carefully pry open the housing a little to remove the wheel that operates the flap. There is a wide o-ring tire on the pivot for the wheel. This rubber ring provides the drag. With age it is slick and maybe shrunk a little.

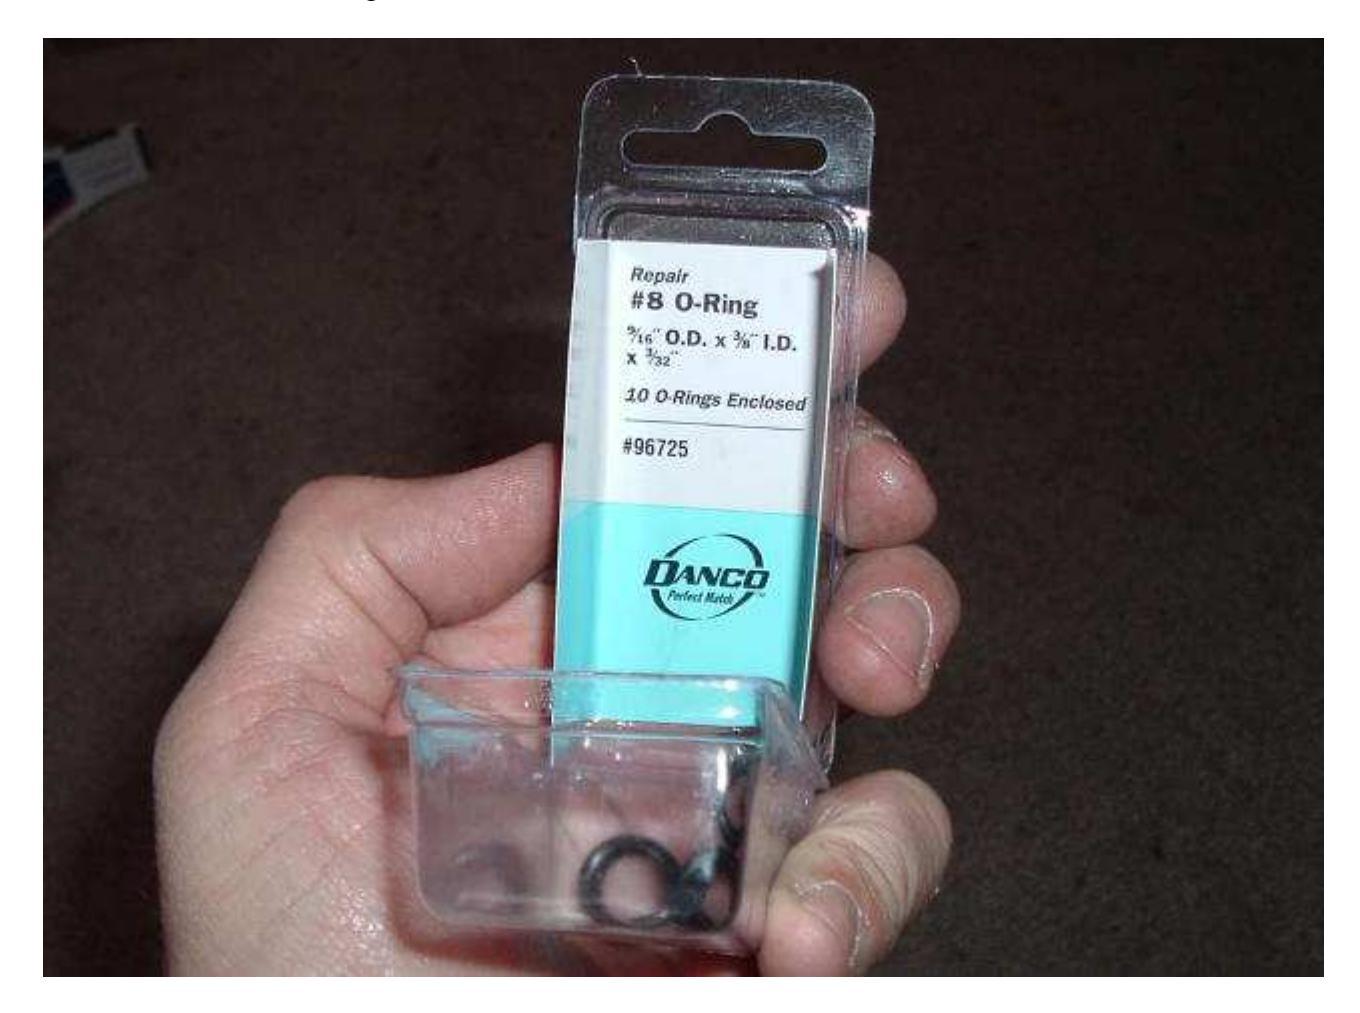
Time to go to Home Depot. I took the old oring and wheel with me and selected the parts below. Two of these orings should do the trick.

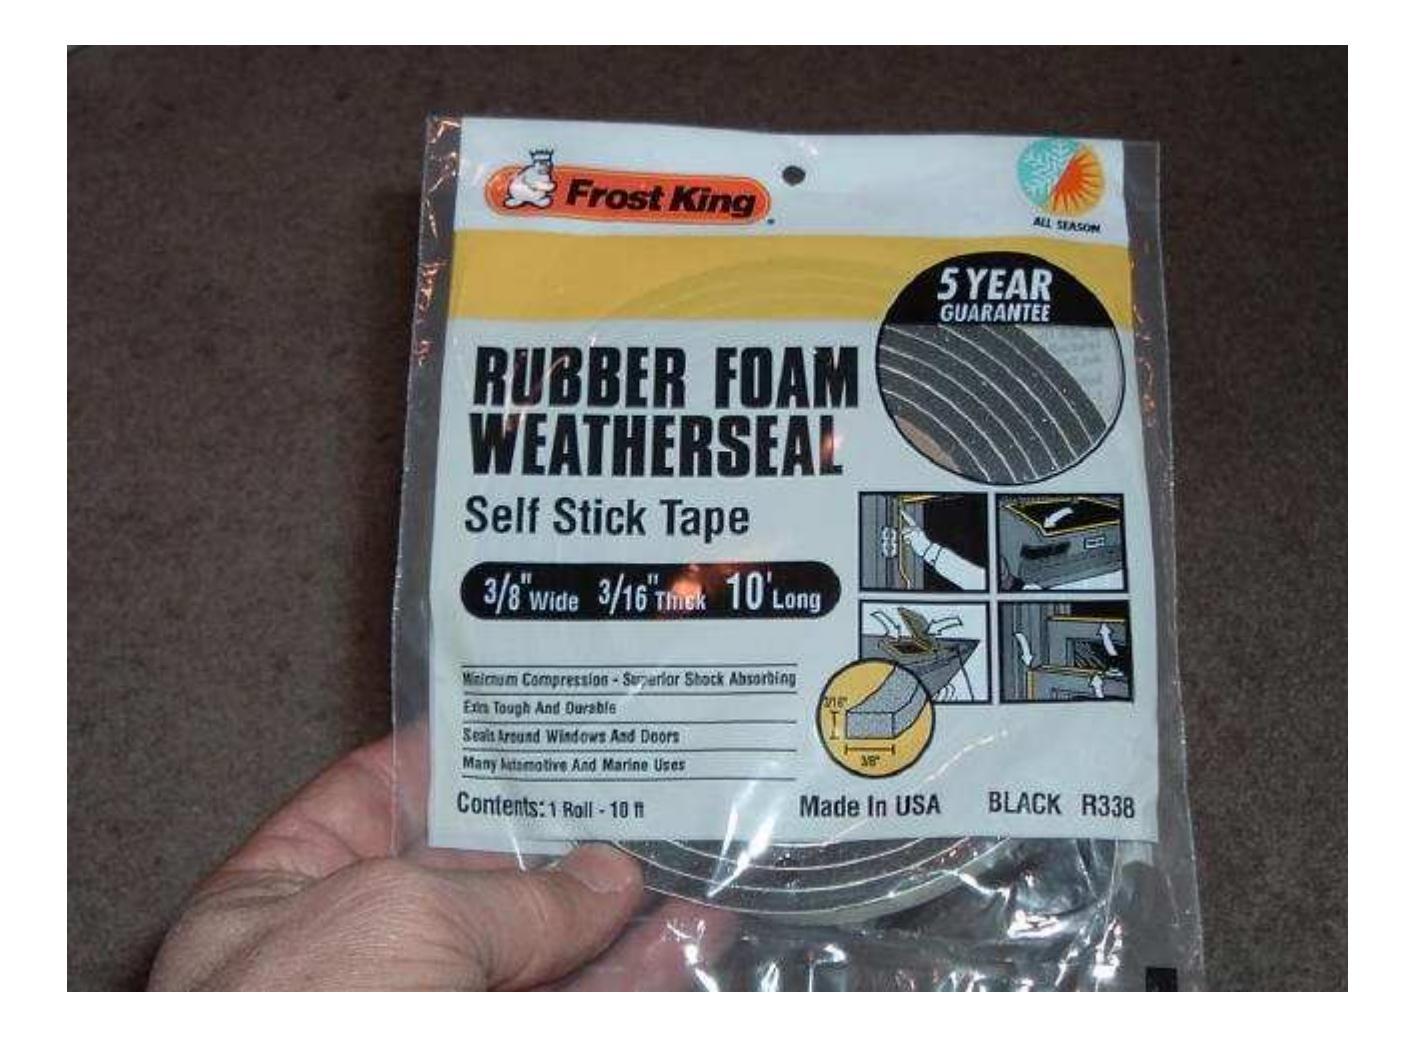
And some foam weatherstripping.

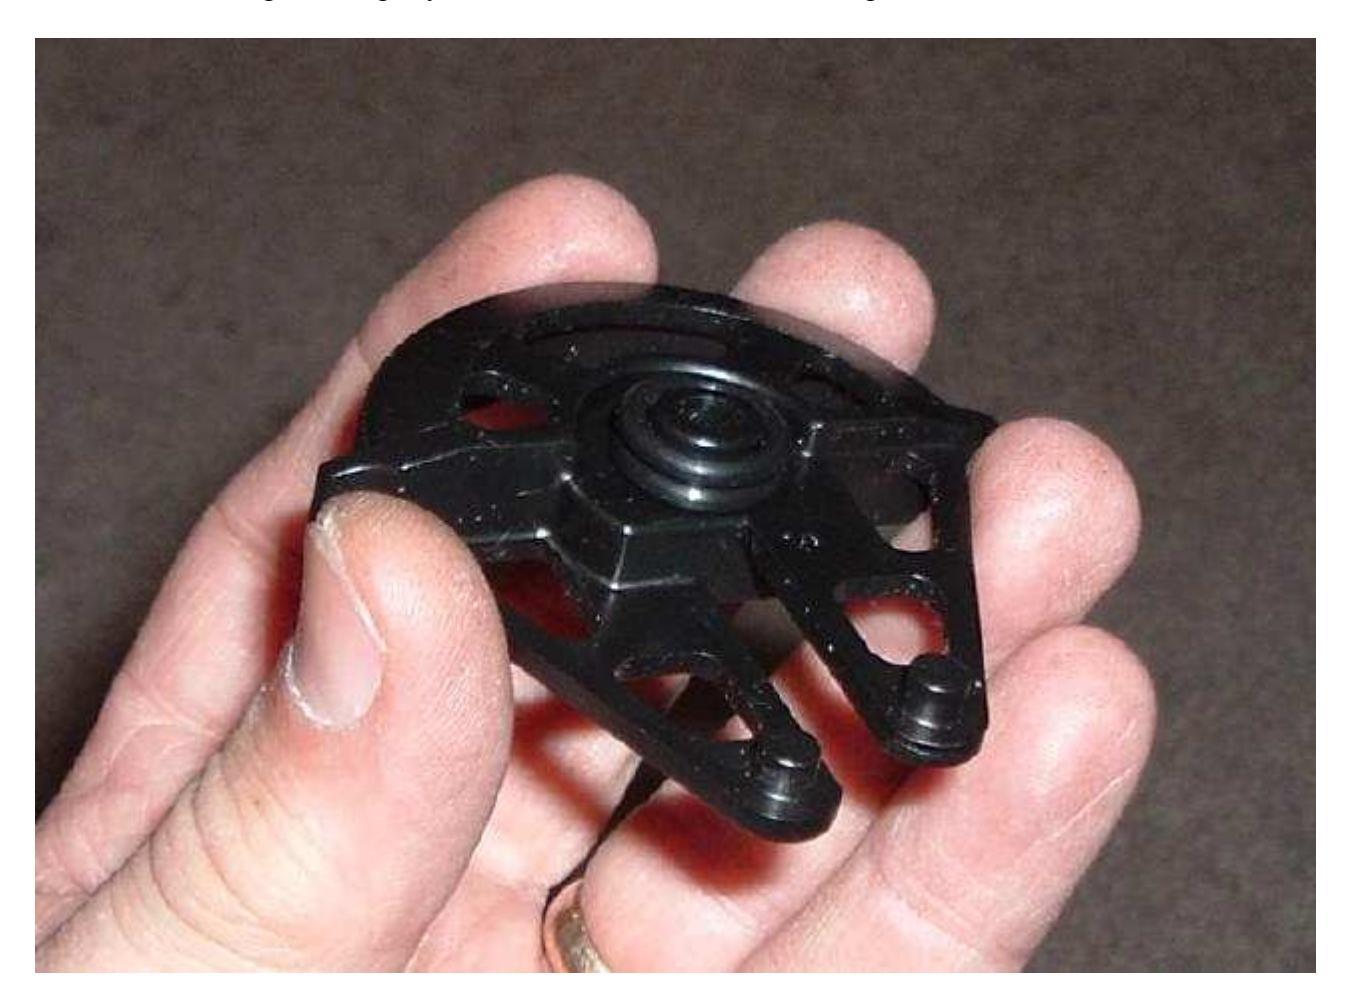
The two new orings are slightly wider than the old tire, which is good.

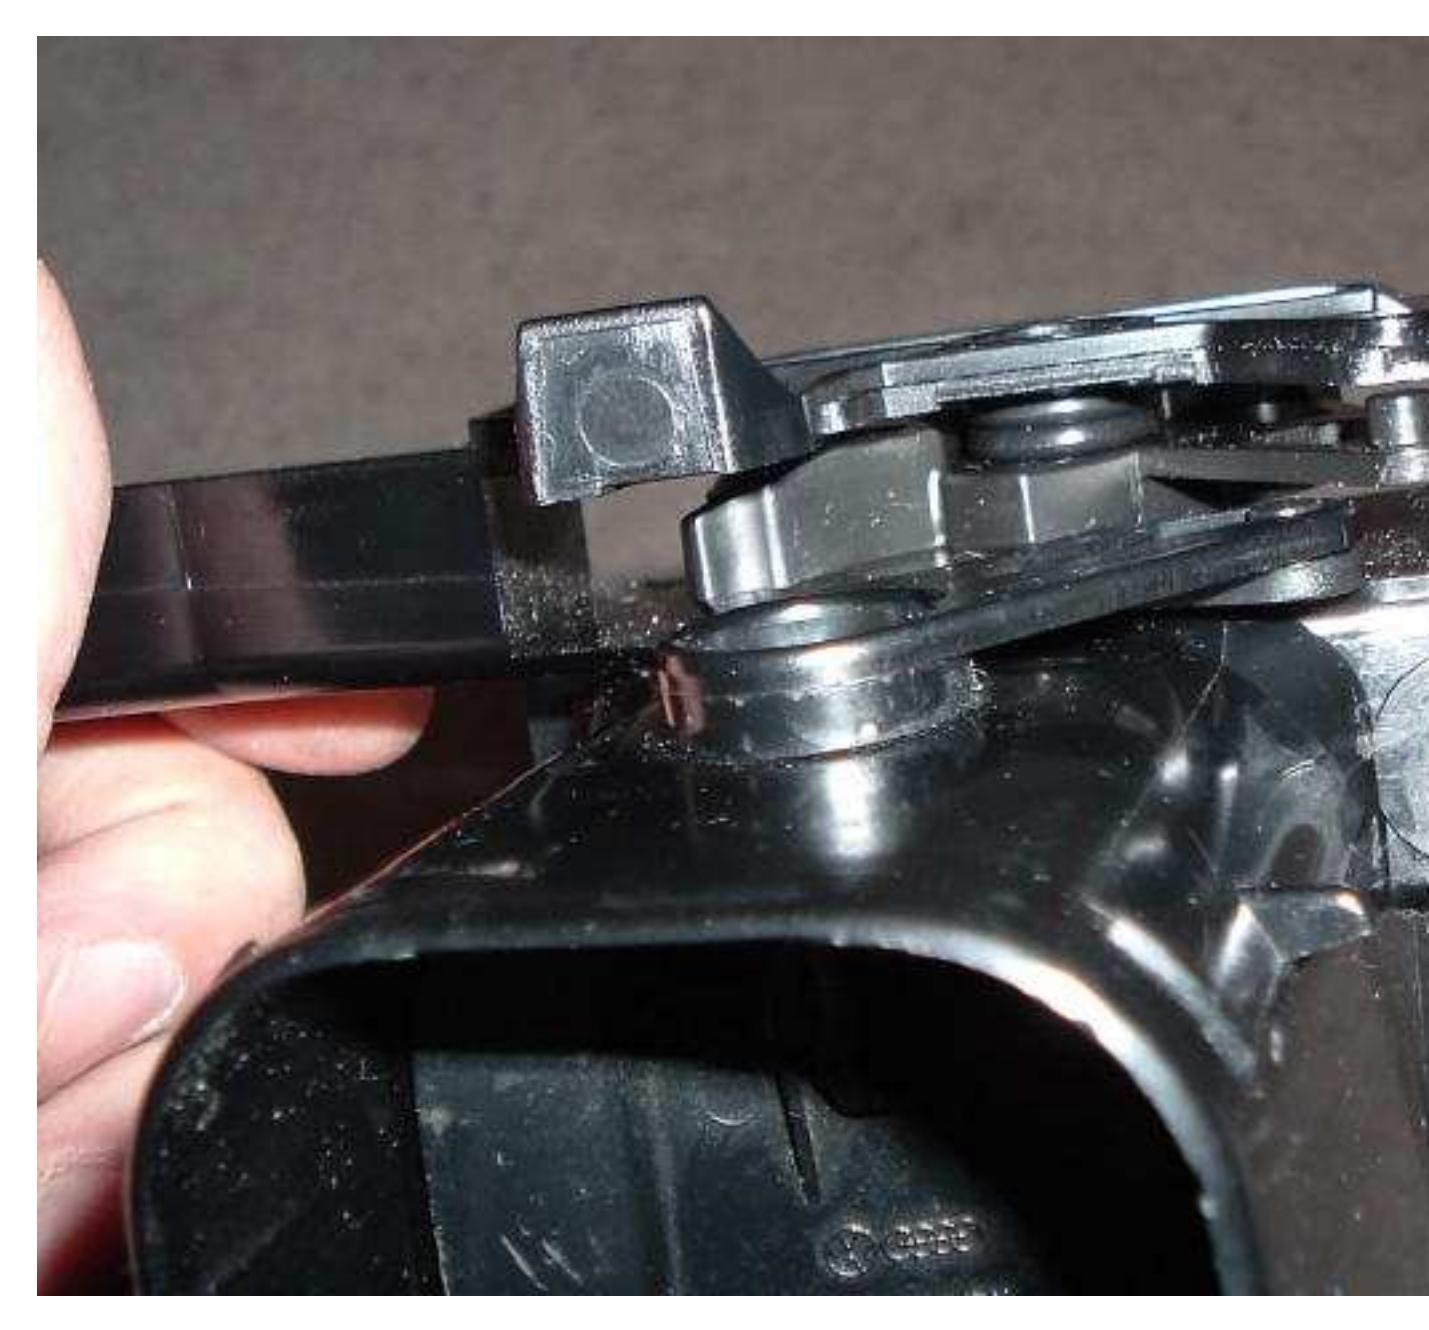
You can see them in position with the wheel installed. The flap linkage is not connected in this pic.

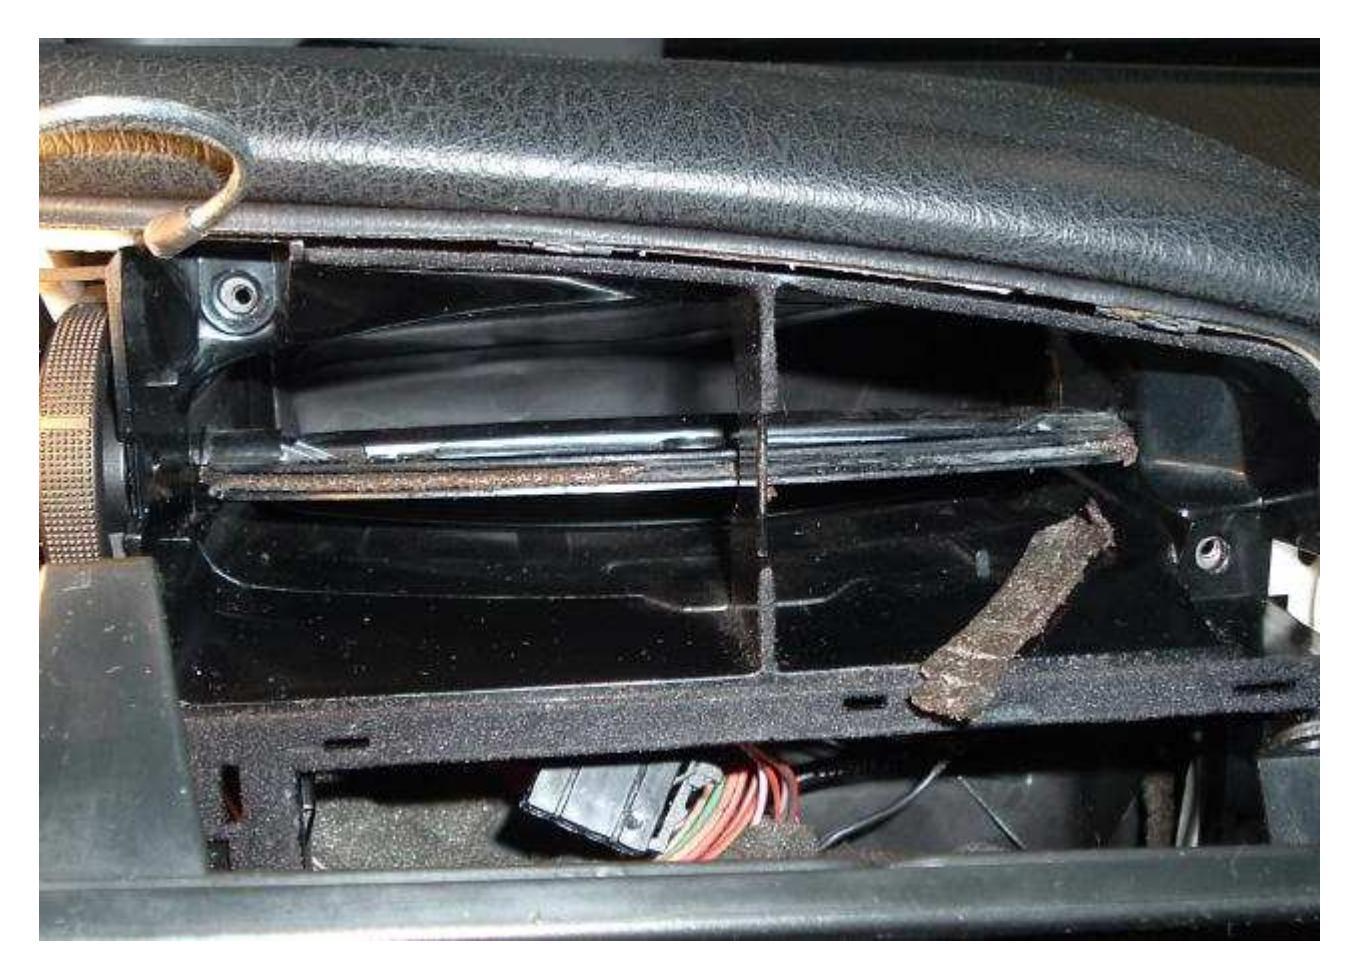
Now for the center vent. Here's what it looked like before.

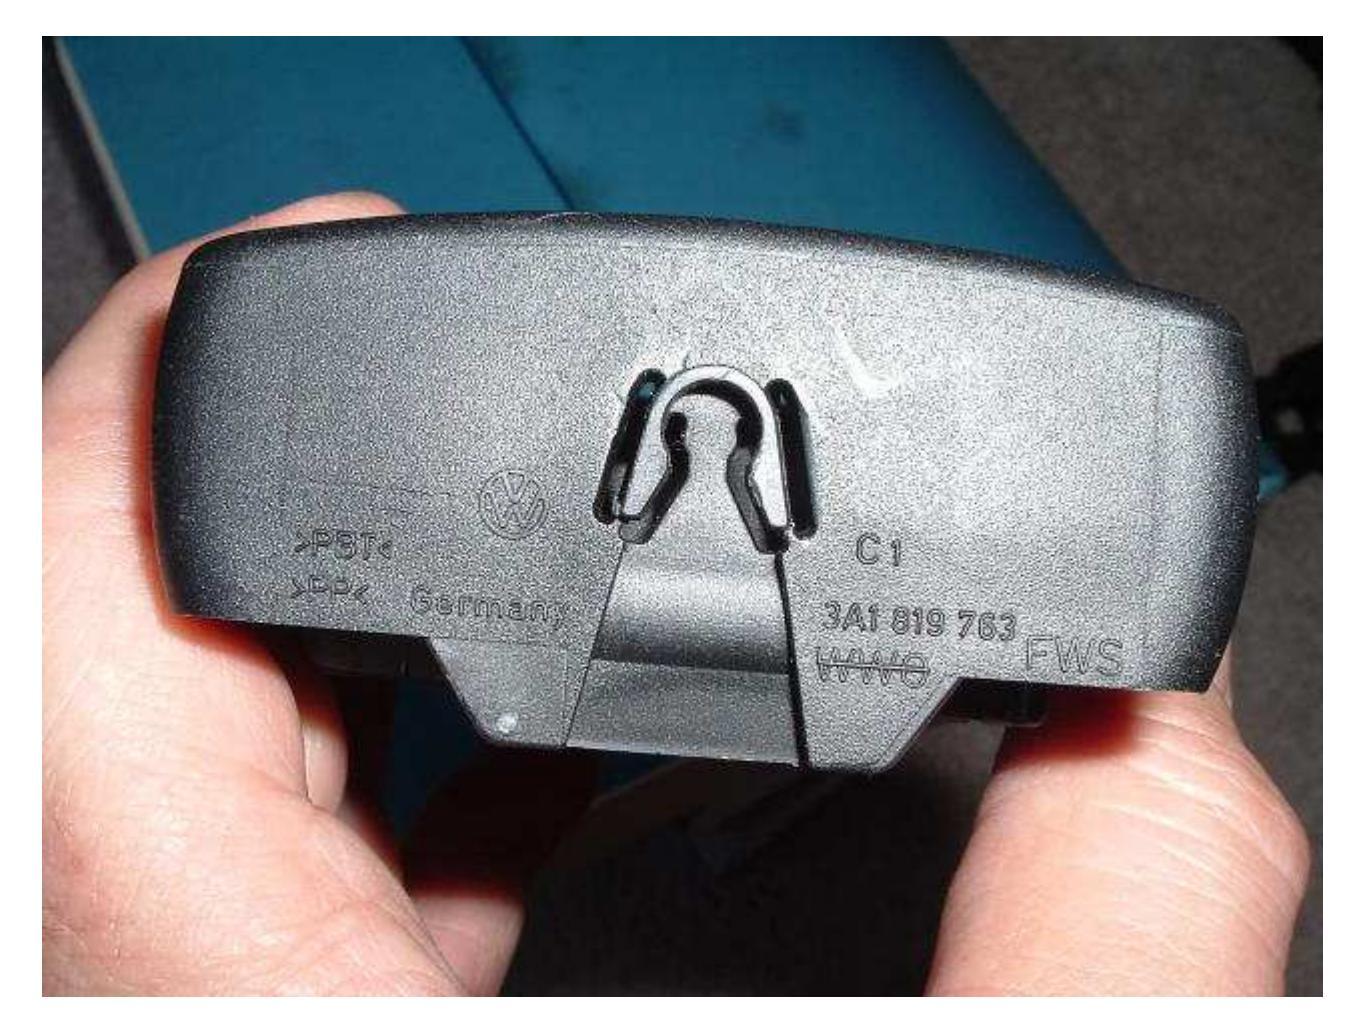
Now for the problem with the vent heads that flop or have to be wedged in place. Unfortunately, there is not a good easy repair for this. The head pivots on two pins on the vent housing. One end of the head has a fixed plastic clip. You can see, at 5:00 and 7:00 in the picture, thin plastic strips connecting the clip to the body. This allows the clip to spring open a little as you snap it in the vent. If one of those thin connector strips is broken, that end will be loose, but it should not affect the drag very much. If anything, it would cause that end to not stay snapped in well.

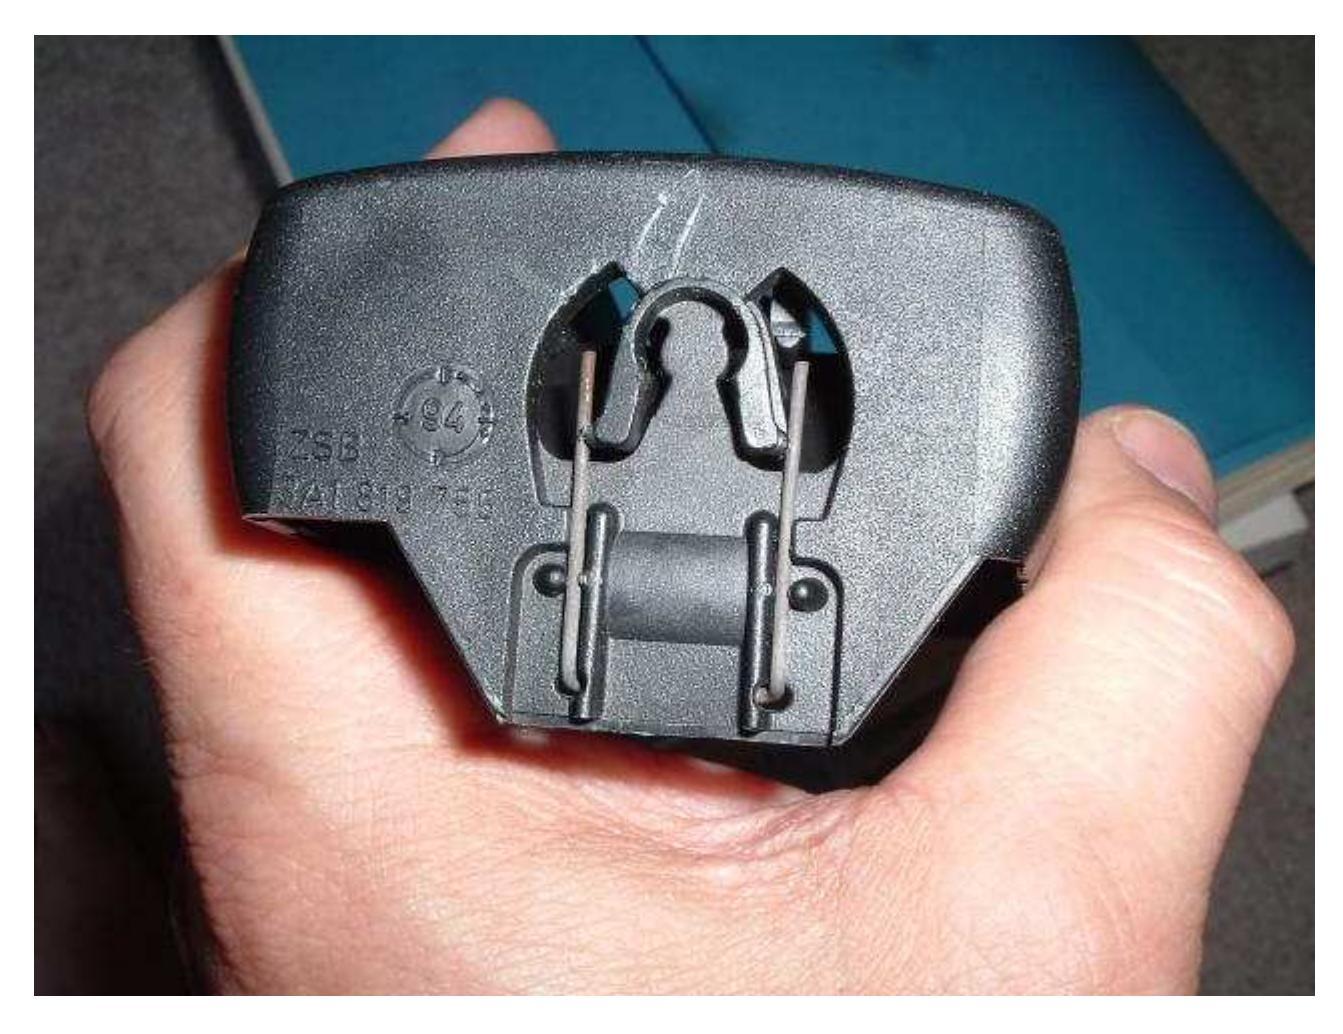
The other end has a tension spring applying pressure to the clip. This is to provide the drag that holds the vent head in position. One of my vents was floppy, and I found that one end of this spring had been dislodged from the clip, I'm sure by me on a previous repair. Putting it back in position cured my floppy vent head.

I could see some wear marks on the pivot pins and inside the clips. I'm sure that new parts would have more drag, but if mine get any looser I think I will try to bend the spring ends a little to increase the pressure on the clips. For now they are not loose enough to fall, they are just a little too easy to adjust. Fortunately, this can be easily worked on at any time since removal does not require any disassembly of the dash.
